LLANHARAN COMMUNITY COUNCIL

Minutes of the Open Spaces, Rights of Way and Allotments Committee (ORA) Meeting held remotely at 7.00pm on Tuesday 3rd July 2025

ORA2025/40 Inspection results of the Council's playgrounds carried out in June 2025

ORA2025/041 Results of the Tree inspections carried out in April 2025 Noted.

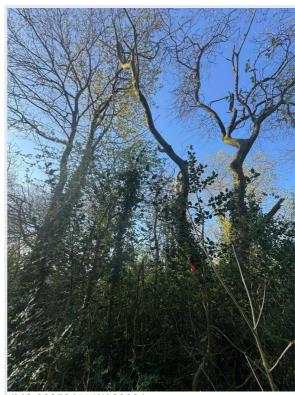
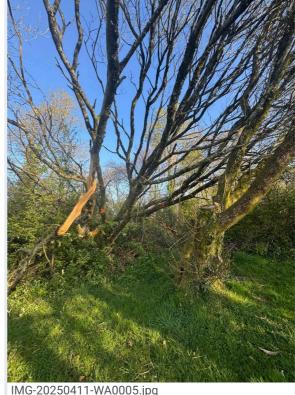
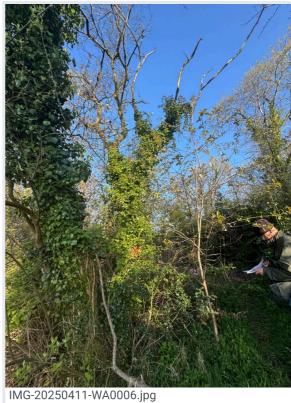
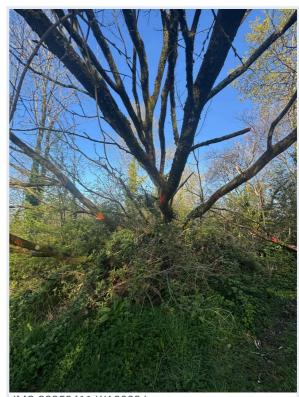
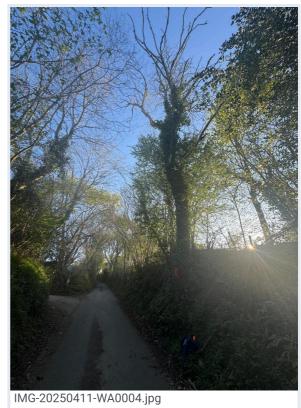
Date Inspected:	24/02/2023
Comments:	1 x mature ash overhanging Gelli Fedi Road junction - at Class 2 - 3 of ADD - marked with orange cross. 6 x mature ash along bank above Gelli Fedi Road/edge of play area marked with orange spots for reinspection in 12 months time.
Ash Die Back Present:	Yes
Massaria Disease Present:	No

Massaria Disease Present:	No
Maintenance	
Work required:	Fell, Re-inspect, Remove Deadwood
Tree comments:	The 6 x smaller infected ash in the copse along the NW boundary of the site which also overhang the adjacent highway - Gellifedi Road - remain in reasonable condition and have not yet passed Class 1 stage of the disease. However, the large ash overhanging Gellifedi Road located 50m NE of the junction with Gellifedi Rise and just SW of the footpath junction - which was at Class 2 stage of ADD and marked for removal at my last assessment has not been remediated and is now at Class 3-4 stage of ADD and a significant failure hazard.
Maintenance Comments:	Trees marked with fresh paint for id purposes and a

current photo has been added to this record. Elsewhere in the group - mainly

along the S edge of the copse and in its interior - 3 further hazardous goat willows require remediation.

Site reassessed this day in company with Mark Steer, a local Councillor. The 2 x willows flagged up for work in my original assessment have been remediated satisfactorily. Firstly a large multi-stemmed mature tree which has been partially windblown during recent severe winter storms and is now hung-up in adjacent trees over an access footpath. Secondly and thirdly, two further mature trees with dead stem/branching overhanging access footpaths. All 3 trees have been marked with orange paint for id purposes and and current photos added to this record. Site for review during next Taff area survey cycle in 2026/2027.

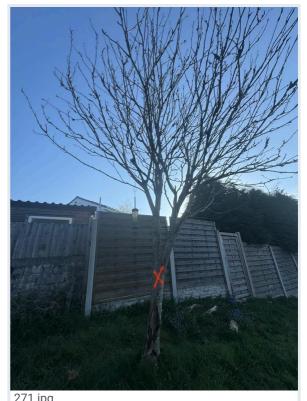
271.jpg 16/04/2025

Comments:	3 x moribund rowan- dead/dying due to basal damage and damp nature of site. Trees marked with orange painted crosses.
Ash Die Back Present:	No
Massaria Disease Present:	No

Maintenance	
Work required:	Fell
Tree comments:	Site reassessed this day in company with Mark Steer, a local Councillor. The rowan at the SE end of the site behind no. 238 Meadow Rise is now moribund and ready for immediate replacement.
Maintenance Comments:	Consideration should still be given to replanting these ailing specimens with more suitable native damp site specialists e.g. Betula nigra. Tree photo re immediate removal added to this record.
Additional / consultant comments:	The growth of the 2 other semi mature rowans at the bottom of the bank in the dampest area of the site along the S boundary adjacent to rear of no's 9/10 Hillcrest remains poor in comparison with other better examples higher (& drier) up the bank with low levels of vigour and vitality. Site for review during next Taff area survey cycle in 2026/27.
